Unfortunately we found a problem with the included adapters from item 84948 Delock Magnetic USB Charging Cable Set for 8 Pin / Micro USB / USB Type-C™ anthracite 1.1 m

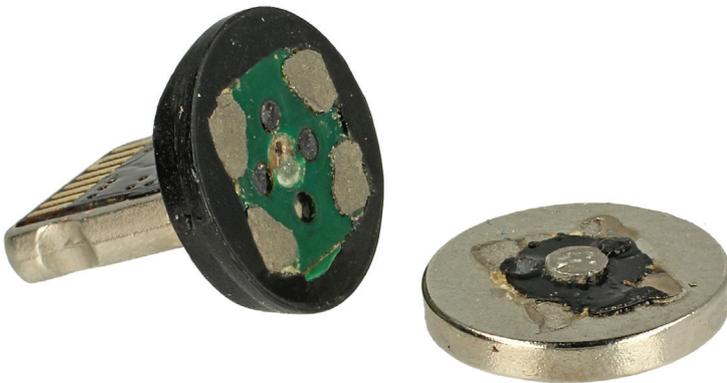
The 3 included Magnet-adapters show defects in the manufacturing. Hence there are chances that the magnetic contact can fall apart from the interface. In this case a short circuit on the device may occur, when another charging process will be attempted.

Currently the number of damages is very low. Still we kindly ask all customers to contact their dealers for the further process of return and refund of costs.
